ONE WORLD TRADE CENTER FIRE

New York, N.Y.
February 13, 1975

HIGH-RISE FIRE SAFETY

**INVESTIGATION AND REPORT BY
W. ROBERT POWERS, *Superintendent***

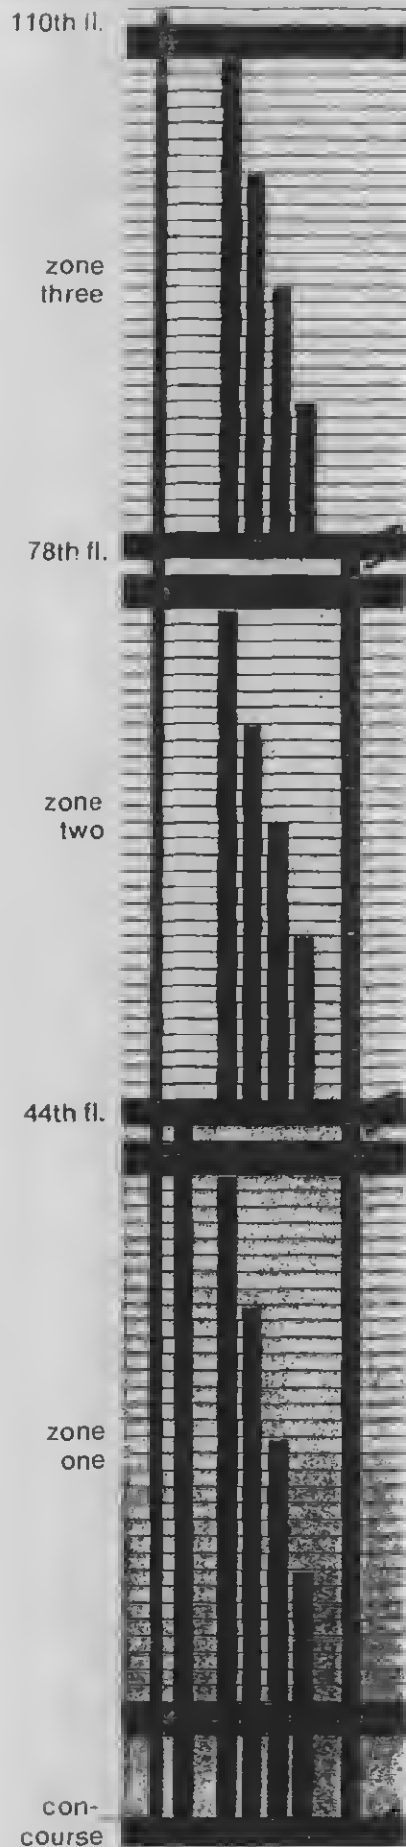
Schematic view of Tower building elevators shows how express and local runs are separated.

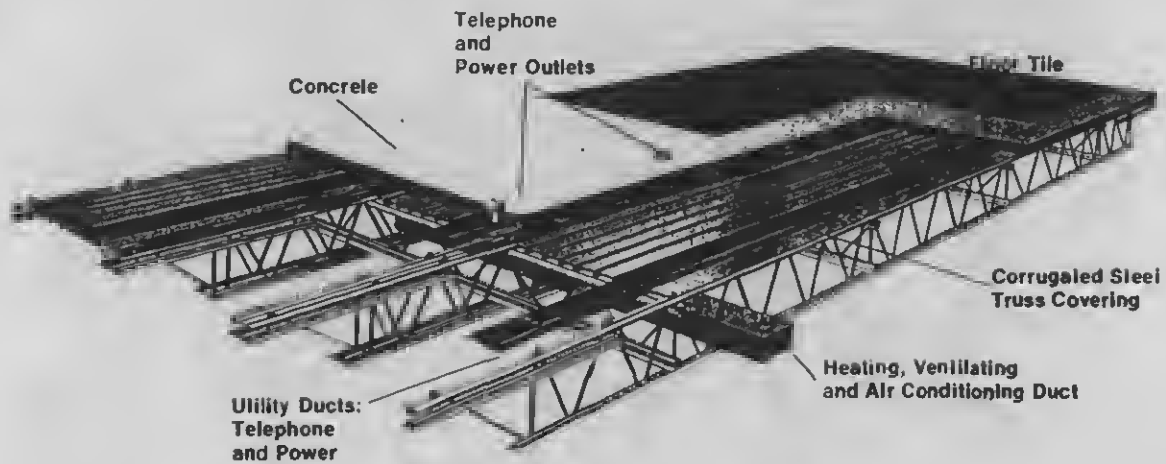
Floor truss in close-up detail. Following placement of truss, the corrugated top was covered by concrete floor slab and tile surface. Underneath, a network of utility and air conditioning ducts traverse the 32-inch deep-cavity.

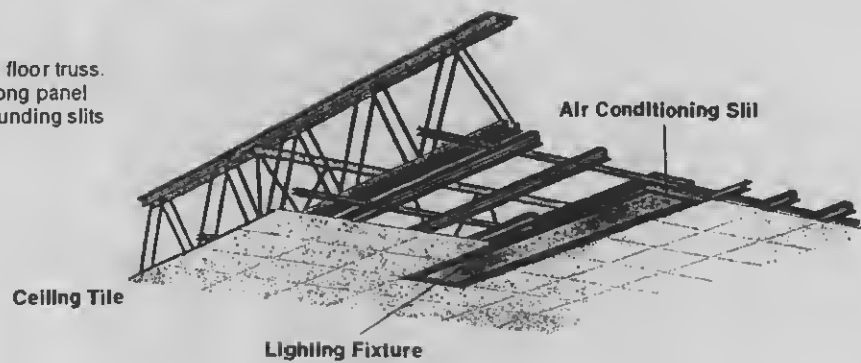
Looking upward at the same floor truss. Ceiling tile is in place. The long panel provides lighting, with surrounding slits for air conditioning.

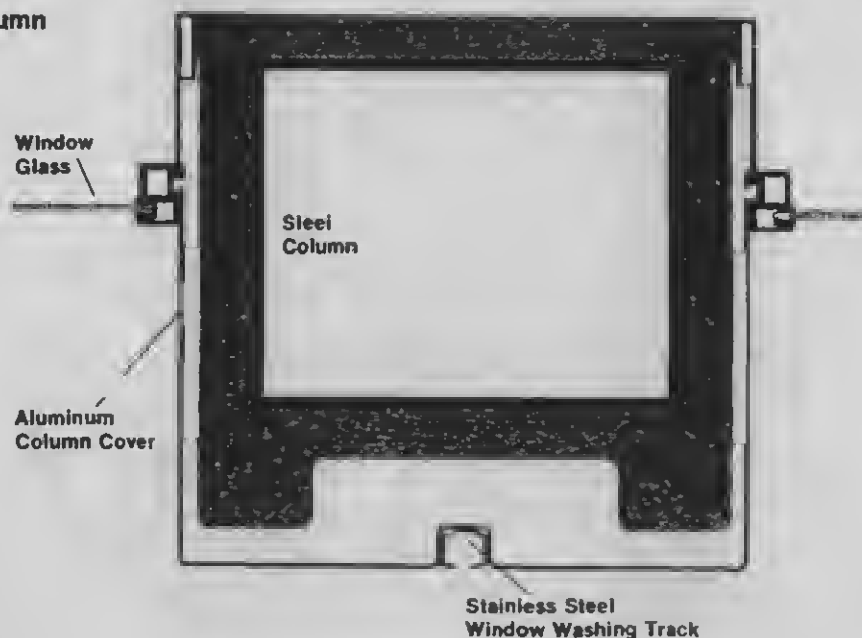
Exterior Wall Column (Plan view)

steel columns with concrete floors. The area between the core and the outerwalls is column-free on the lower levels providing about 30,000 square feet of clear office space. Concrete in the core was poured on forms while in the remainder of the building, fluted steel forms were used. These concrete floors butt against the exterior steel spandrel beam so no vertical flues are formed. In addition, the interior face of the exterior columns is protected by plaster so that no vertical flue exists at this point. The spandrel beam is sprayed with vermiculite plaster to provide the vertical fire separation between windows. The steel bar trusses and interior columns are protected with Cafco Type D sprayed fibre to protect them from fire. All vertical shafts are enclosed by 2-hour fire rated walls consisting of 2 one-inch thick sheets of gypsum plank between H channels and one layer of 5/8" plank on one or both sides. The fluted steel forms have no fire protection on the underside except that a five foot wide strip of sprayed fibre has been applied under the trench headers.
